ANNUAL REPORT FOR 2009

Setman Branch Mitigation Site
Rowan County
TIP No. R-2911E

Prepared By:
Natural Environment Unit & Roadside Environmental Unit
North Carolina Department of Transportation
October 2009

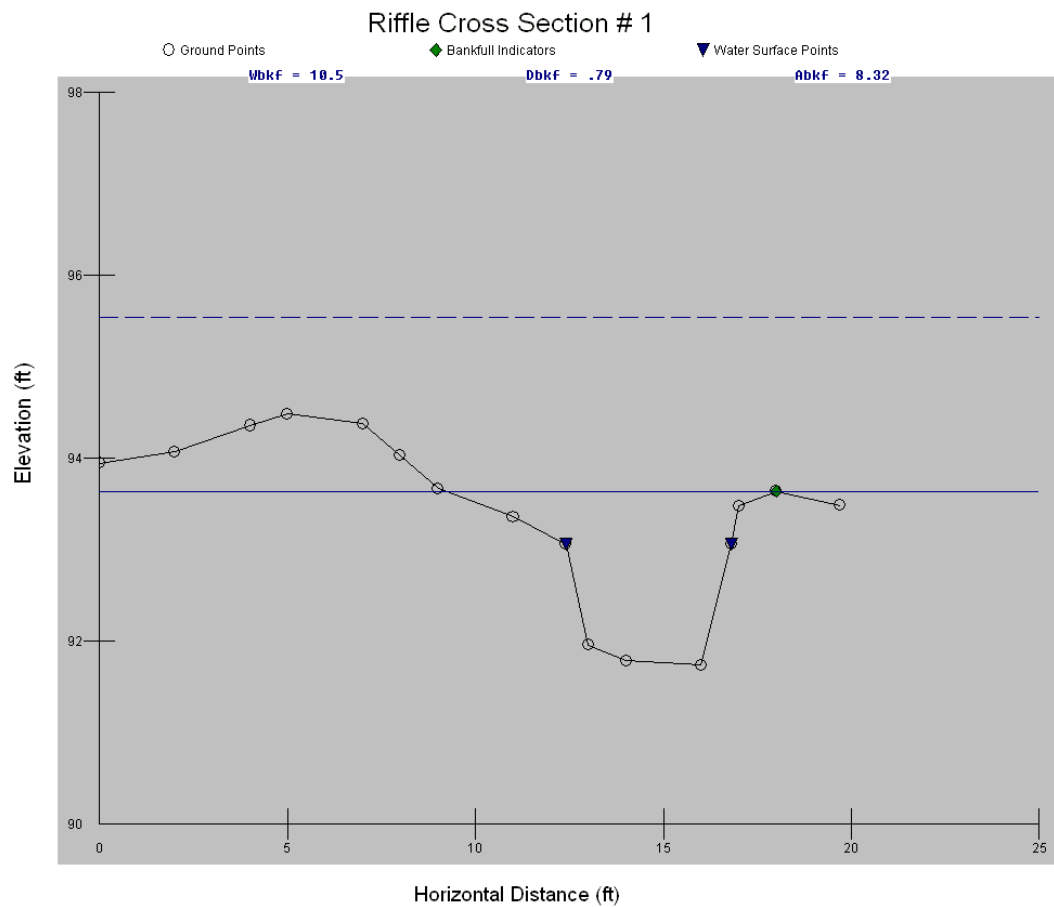
Cross-Section #1 (Riffle) Abbreviated Morphological Summary

Based on comparisons of the Year 2007 to the Year 2009 cross section data, the riffle cross section appears stable with little or no active bank erosion. A graph of the cross section is presented in Appendix A. Future survey data will vary depending on actual location of rod placement and alignment, however, this information should remain similar in appearance.

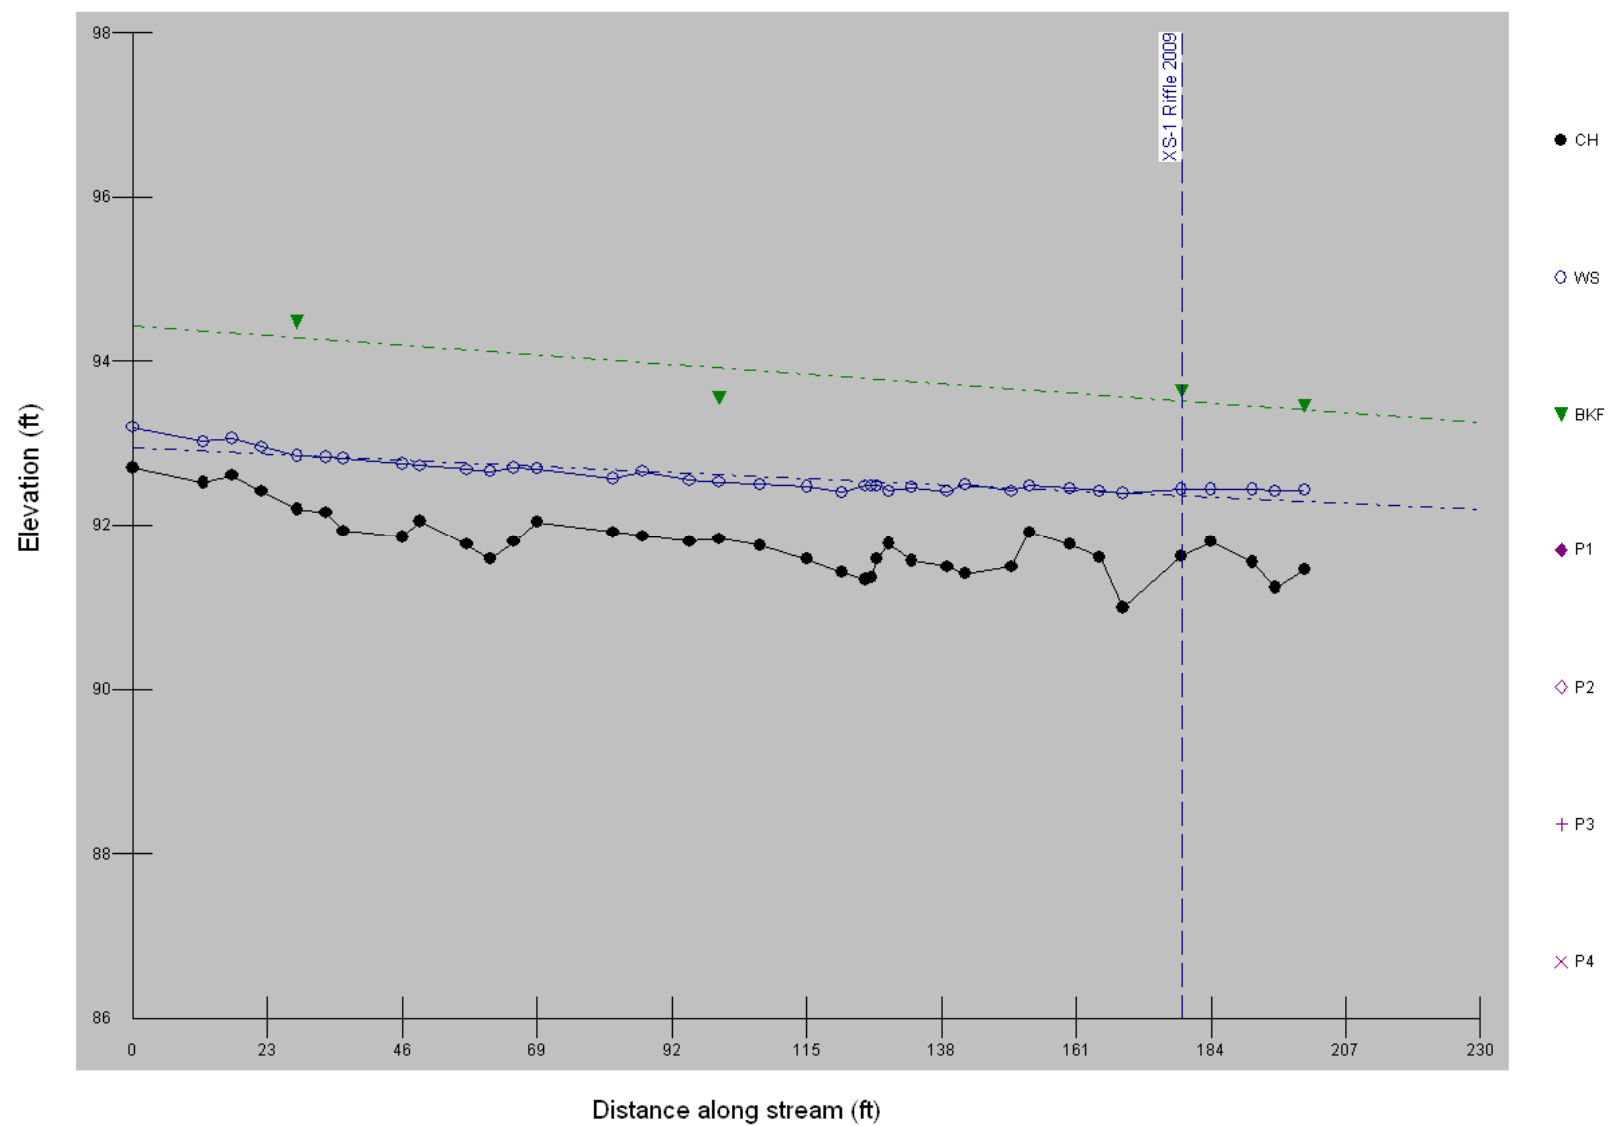
Setman Branch

The longitudinal profile showed that the length of the channel is stable and functioning properly. A beaver dam located downstream of cross section #1 and outside of the profiled channel was removed. NCDOT will continue to monitor the channel for stability and beaver activity.

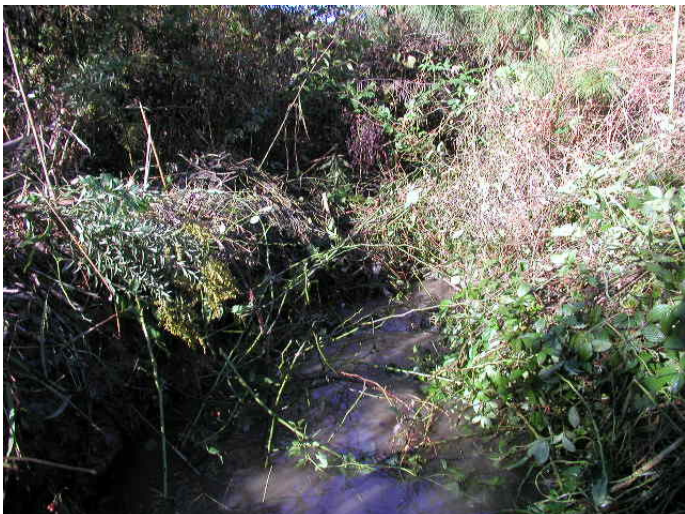
Removed beaver dam located downstream of XS #1
October 2009
